**ORAL HISTORICAL, DOCUMENTARY, AND
ARCHAEOLOGICAL INVESTIGATIONS OF BARTON AND
VINTON, MISSISSIPPI: AN INTERIM REPORT ON
PHASE II OF THE
TOMBIGBEE HISTORIC TOWNSITES PROJECT**

**A report on work undertaken in cooperation
with the Mobile District, U.S. Army Corps of Engineers,
in partial fulfillment of Contract No. CX4000-3-6065
of the National Park Service, Mid-Atlantic Region**

**The Museum
Michigan State University
May 1983**

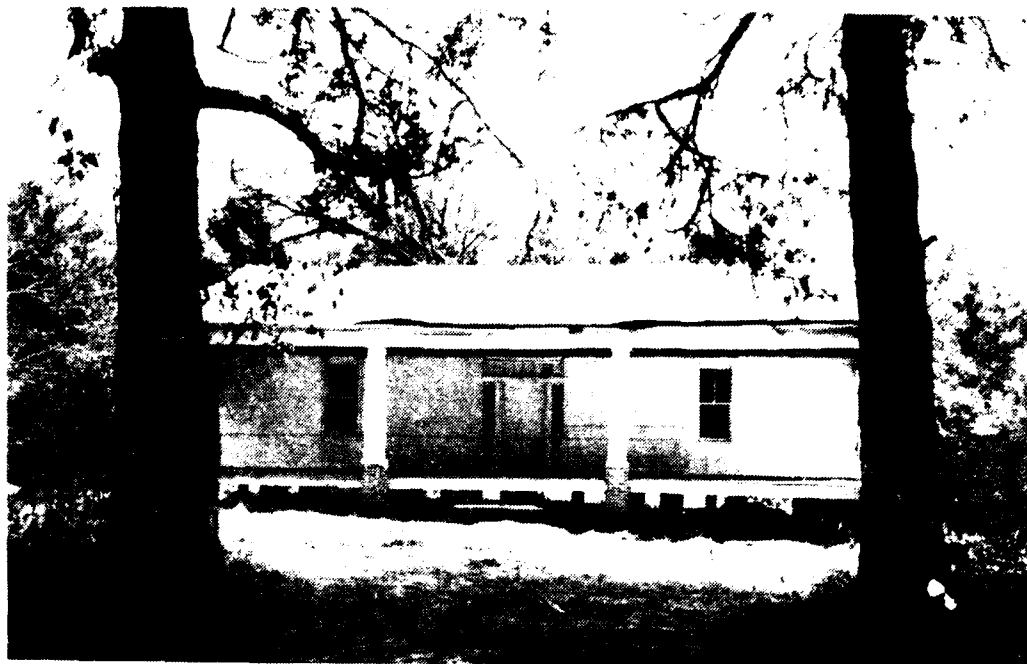
Figure 4. Front View of House Known as "Cedar Oaks", Looking East.

The architectural style of the Cedar Oaks house can be described as vernacular Greek Revival (Figure 4). Supported by brick piers, it is a one-story structure containing four rooms separated by a central closed hallway; the two front chambers are larger than the rear chambers. Each of the four rooms once contained separate fireplaces and chimneys and although the fireplaces and three of the four chimneys have been removed, the front chambers still retain the original mantel pieces (see Appendix 2, p. 9 for a floorplan drawing of Cedar Oaks). The front of the house is an open gallery and Newton (1980) speculates that the rear of the house may have also had a full or partial length gallery. Evidence for this are the folding rear doors of the central hallway, which are not the type to open directly to the outside (Newton 1980:6). The house structure has been changed only superficially during the twentieth century and remains relatively intact in its original state. One major

change is the replacement of its shingled roof with sheet metal that occurred sometime during the past few decades. Much of the outside siding has also been replaced. According to oral historical and structural information, there was an ell off the northeast corner of the house during the early twentieth century, although it has since been removed (McClurken and Anderson 1981:561-562, 877, 880). A shed remains standing behind the house approximately 7 m east of the northeast corner of the house; it is a twentieth century structure constructed of materials salvaged from an earlier structure (Figure 5). The only other standing outbuilding on the site is a small twentieth century privy in the northeast corner of the backyard. Between the shed and the privy near a huge southern red oak tree there is a bricklined well 16 m deep that may be the original nineteenth century water source for this site. It is similar in construction to other abandoned wells on the Barton townsite and according to oral historical information, it was not used as a water source during the twentieth century occupation of this site. During this time period, occupants used an artesian well to the west of this site as the primary water source (McClurken and Anderson 1981:562, 619, 883-884).

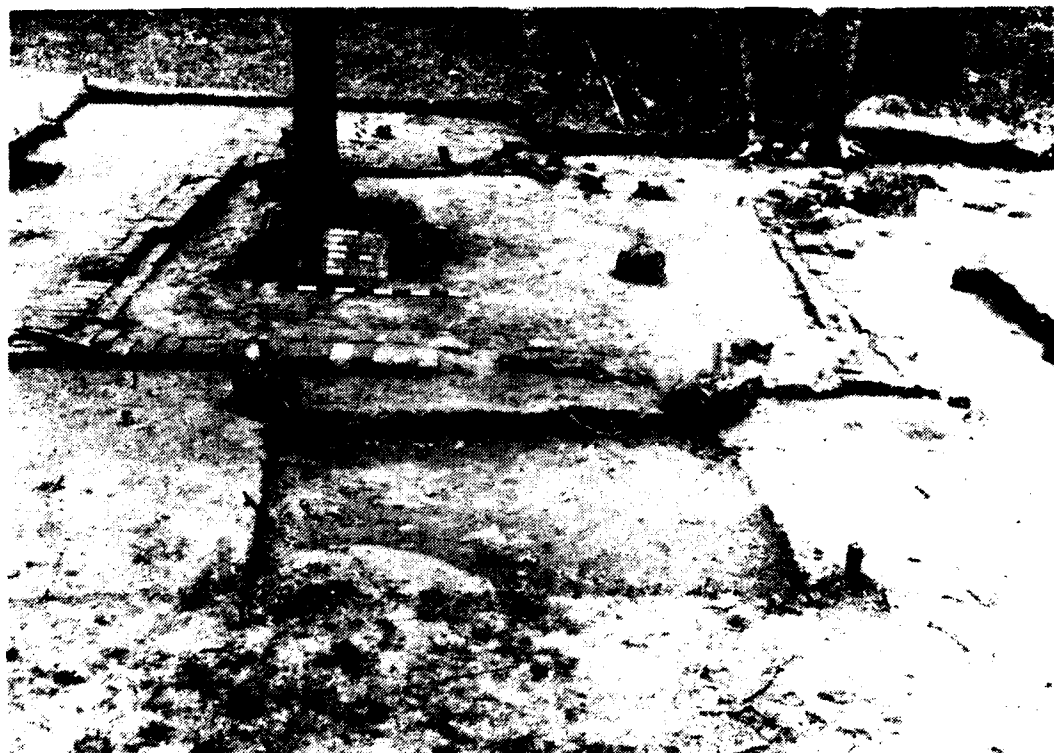
Figure 9. Photograph of Feature 1, Cedar Oaks House Site (22C1809).

Level 1: 10YR3/2 to 10YR3/3 loamy midden. The top course of bricks became visible about halfway into this level.

Level 2: 10YR5/4 very sandy loam midden which occurs only within the confines of the brick foundation. Contains ash and charcoal concentrations in some areas.

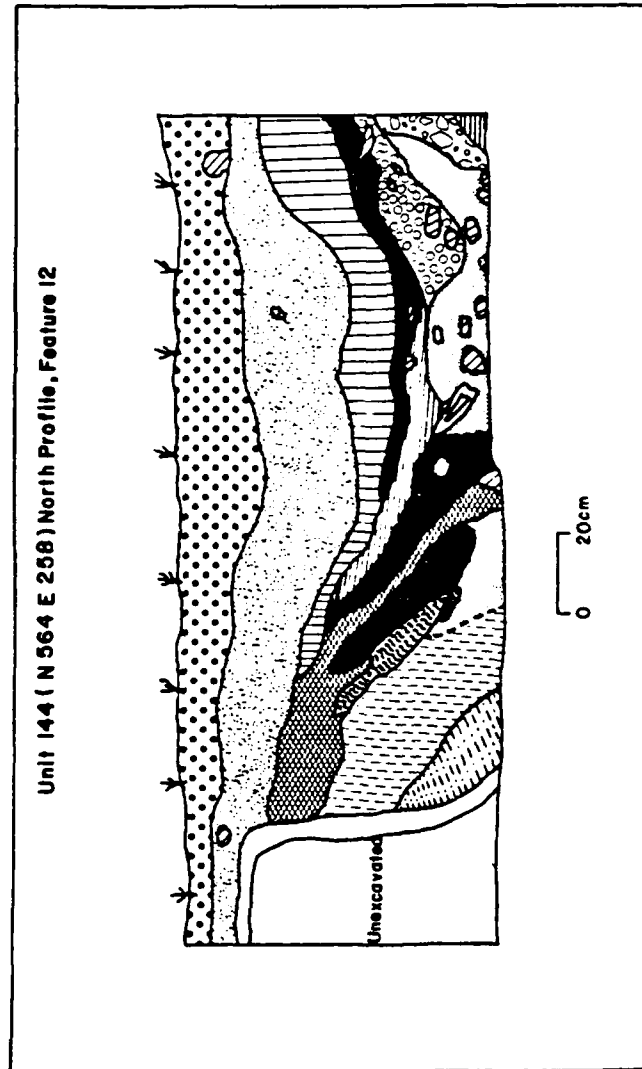
Unit 144 (N 564 E 258) North Profile, Feature 12

Feature 12	A very large pit measuring 1.5 x 2 m in diameter. It probably functioned as a privy or cistern and in the process of use was filled in with cultural debris. The soil is very complex and consists of many dark and light lenses of loam. The darker lenses (10YR3/2 to 4/2) contained a higher frequency of artifacts. The feature was probed to a depth of 2 m and excavated to 80 cm below surface.
------------	--

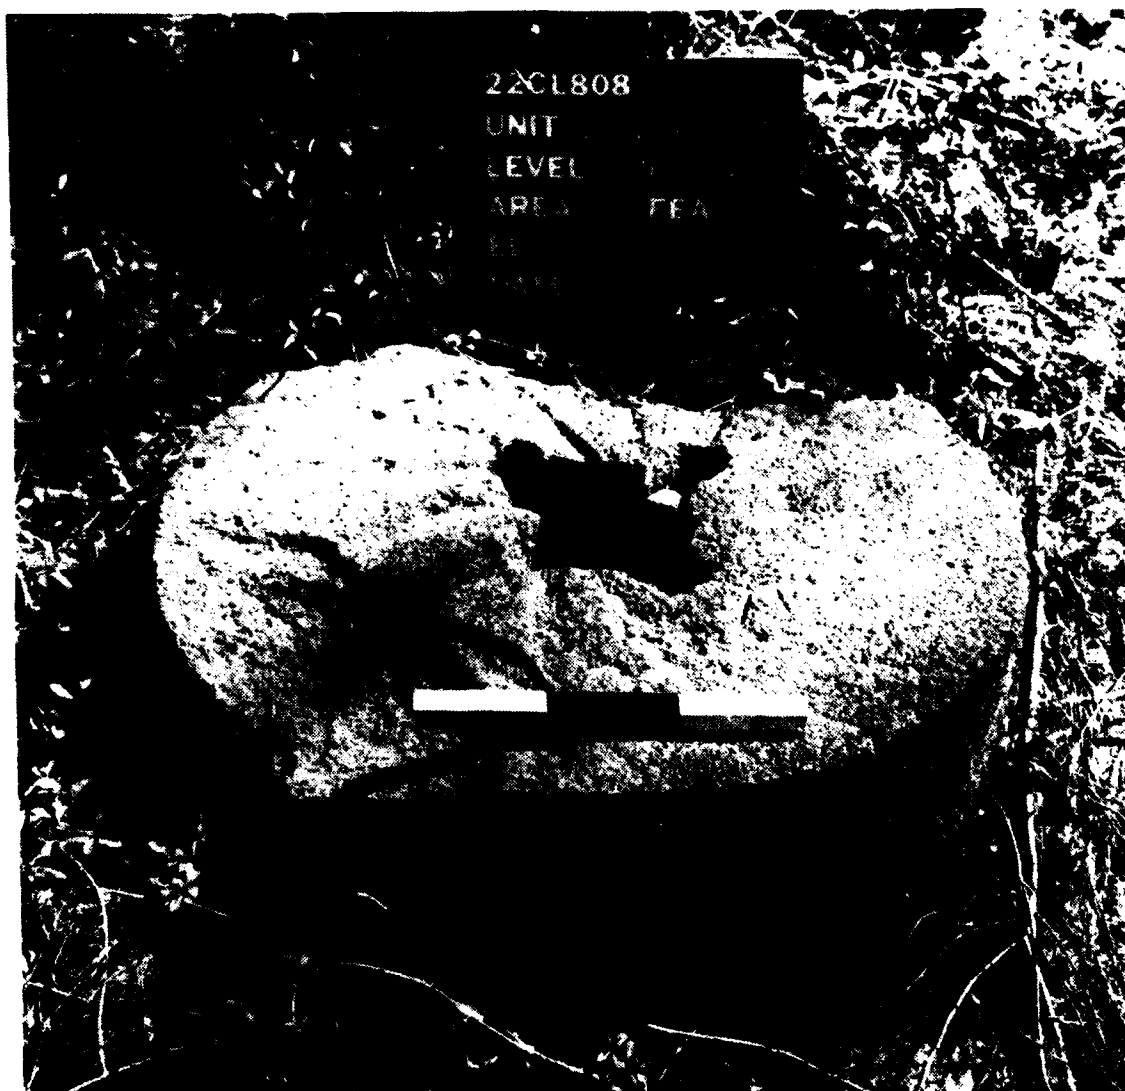
Figure 23. Milling Stone Located at Site V-3, Townsite of Vinton.

Oral historical and archival data confirmed the suggestion that a cotton gin and grist mill operation had been located in this area during the late nineteenth century. Solid dating is as yet unavailable, but

current information indicates that the gin and mill were in existence by 1870 and were destroyed by fire before ca. 1895. A lack of chronologically sensitive material produced by archaeological testing prevents corroboration or refinement of this time frame.
